Inspection Report

Property Address:
1515 Mockingbird Ln.
Milwaukee WI 53601

Date: 6/30/2011	Time: 2:02:00 PM	Report ID: 0923101
Property: 1515 Mockingbird Ln. Milwaukee WI 53601	Customer: John Doe	Real Estate Professional:

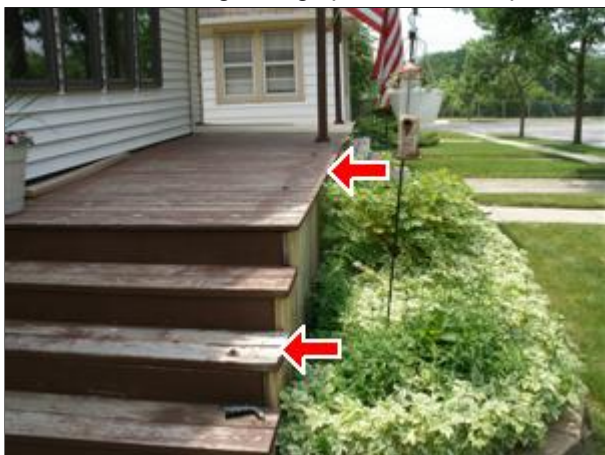
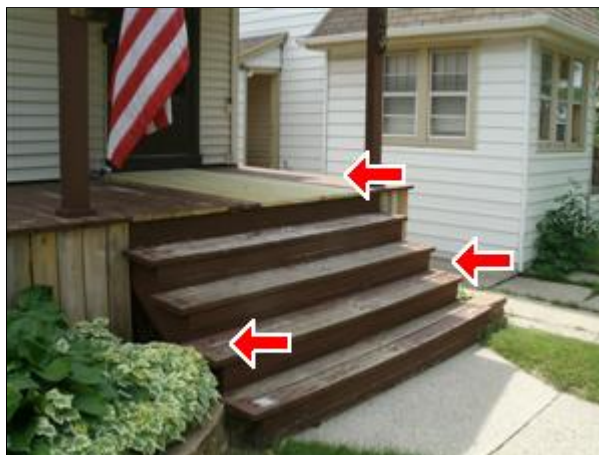
(1) There are some missing railings present on the porch on the north side of home.

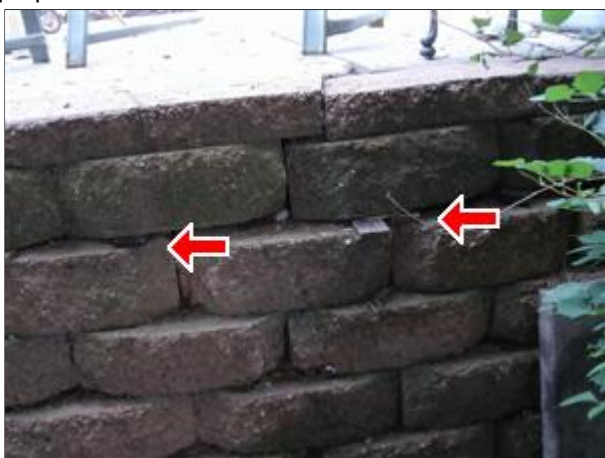
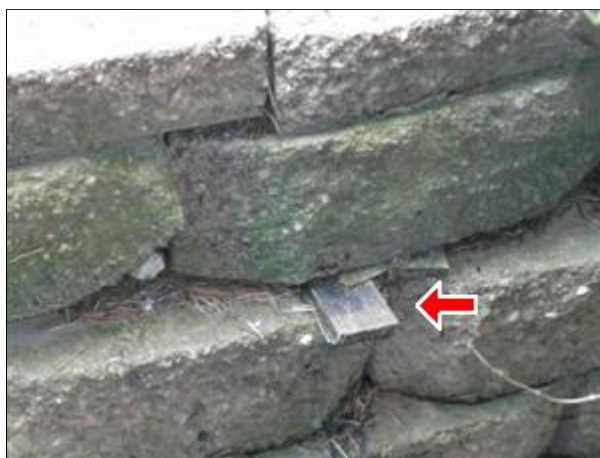
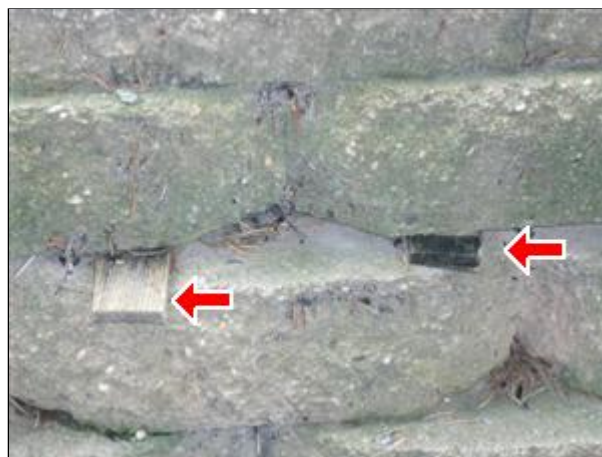
Some retaining wall is settling and has gaps between the blocks. Some wood wedges have been added. Recommend landscape professional for further evaluation.

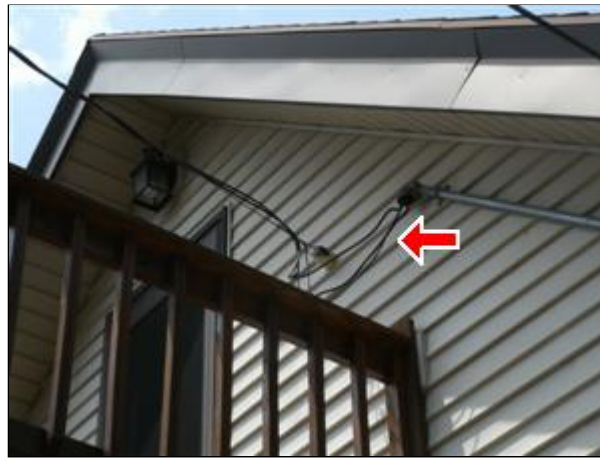
The electrical service conductors clearance from the deck is lower than 10 feet, recommend correcting for safety. Recommend qualified electrical contractor for further evaluation.

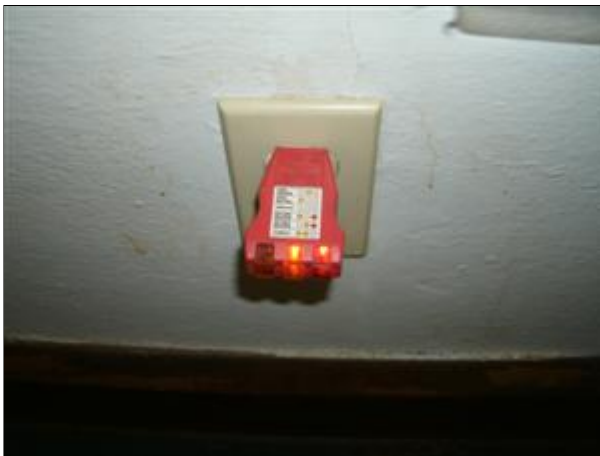
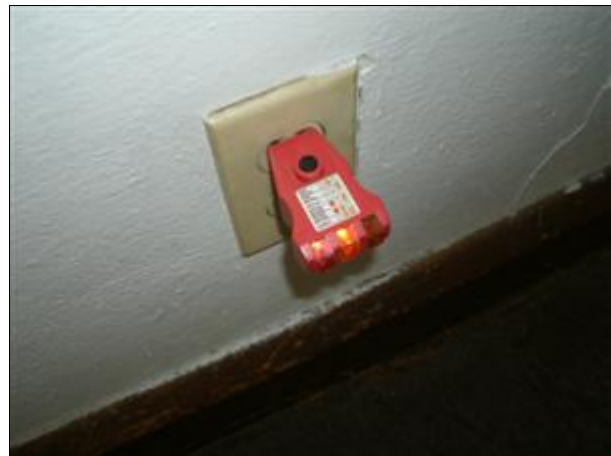
(4) Some outlets are not wired correctly.

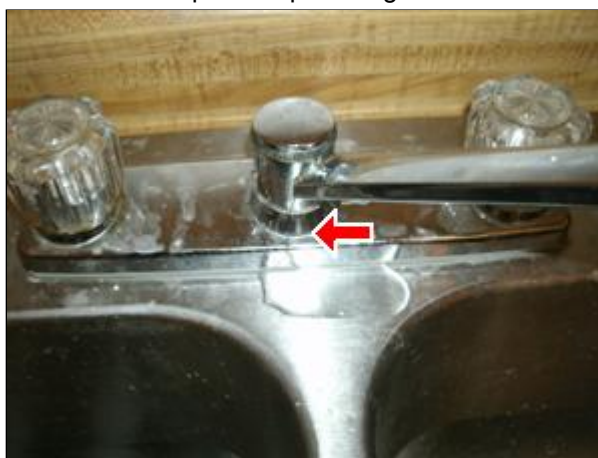
The faucet leaks around the spout. Recommend qualified plumbing contractor for further evaluation.

- The faucet leaks around the spout. Recommend qualified plumbing contractor for further evaluation.

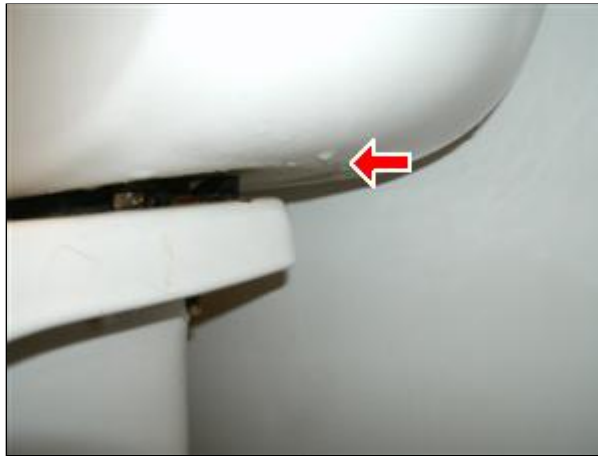
The toilet leaks at tank mount. Recommend plumbing contractor for further evaluation.

- The toilet leaks at tank mount. Recommend plumbing contractor for further evaluation.

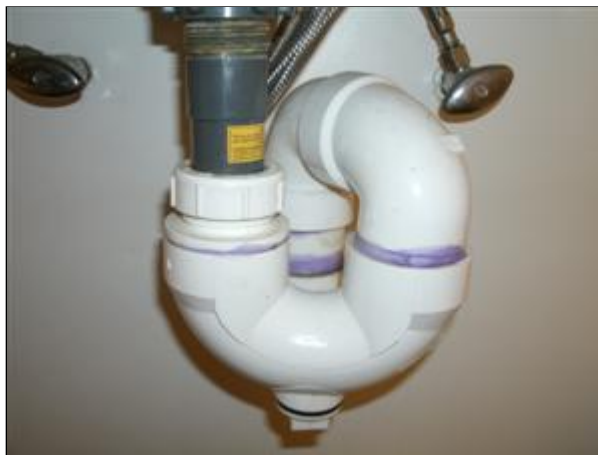
There is an incorrect trap system present. Recommend qualified plumbing contractor for further evaluation.

- There is an incorrect trap system present. Recommend qualified plumbing contractor for further evaluation.

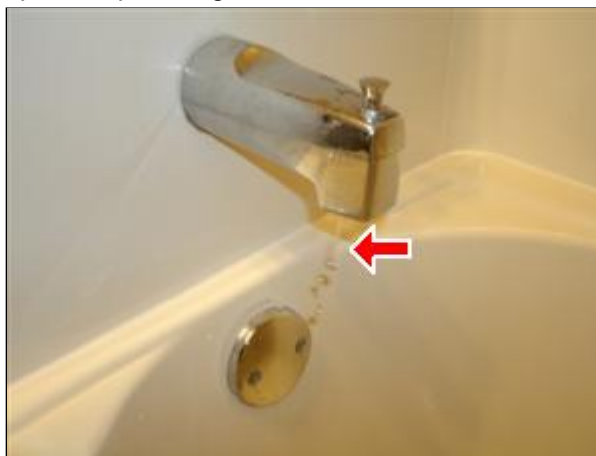
(2) The faucet drips. Recommend qualified plumbing contractor for further evaluation.

- (2) The faucet drips. Recommend qualified plumbing contractor for further evaluation.
